### THE CWP RO HOT WATER HEATER TROUBLESHOOTING

When troubleshooting the CWP RO heater, it is important to diagnose the exact mode of failure as described in this technote so the correct replacement parts can be ordered.

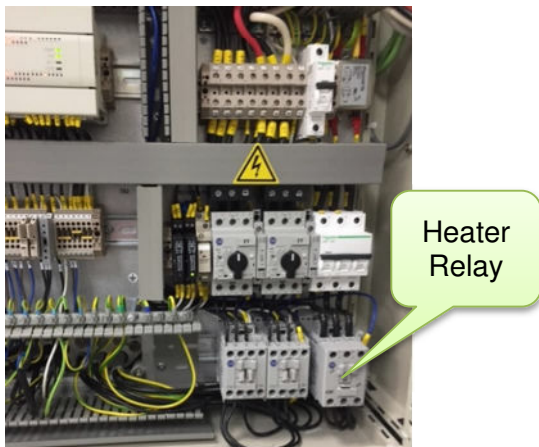
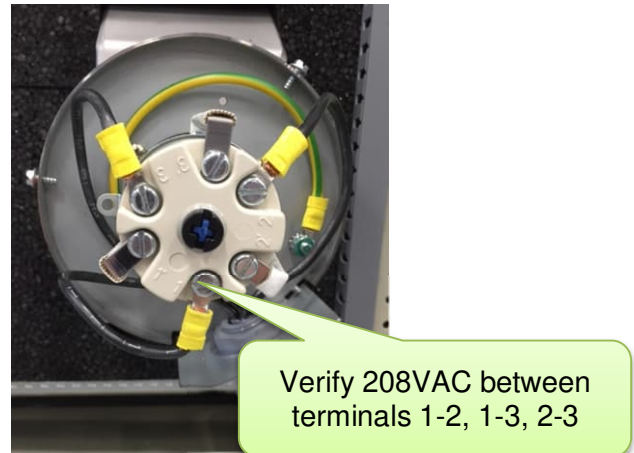
Verify the heater relay is “pulled in”. Verify 208VAC between terminals 1-2, 1-3, 2-3 on the High Limit Switch, see figures below. If measured voltage is not 208VAC  $\pm 5\%$ , consult an electrician. Turn off high temperature mode.

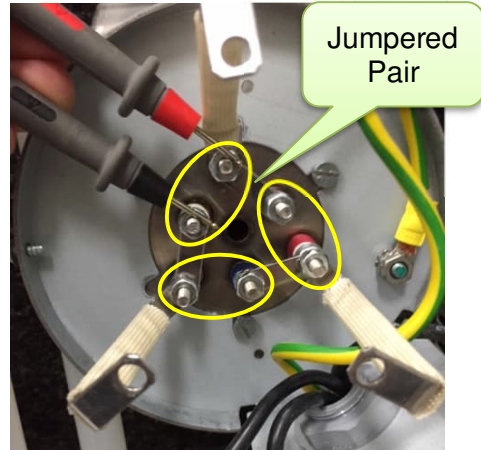
Using an ohmmeter, verify continuity through each of the 3 heater elements. A quick method to verify continuity is to measure the resistance between jumpered pairs, circled in the figure below. The resistance between each jumpered pair should be  $\sim 10\text{-}12 \Omega$ . If a heating element has failed, order kit W3T577811.

Note: The High Limit Switch has been removed for better visualization.

Note: This continuity check does not isolate and measure resistance across individual heating elements. To double check a failed heating element, remove the jumpers and then check resistances. Per specification resistance of each heating element should be  $15.9 \Omega \pm 10\text{-}5\%$ .

- Resistance  $\sim 10\text{-}12 \Omega$  at each of the 3 measurement points means that the heating elements are functional and the root cause of the failure is likely the High Limit Switch.
- If one of the elements has failed the resistance will measure  $\sim 15.5 \Omega$  across two of the jumpered pairs and  $\sim 30 \Omega$  across the remaining jumpered pair. If two elements have failed the resistance will be infinite across two of the jumpered pairs and  $\sim 15.5 \Omega$  across the remaining jumpered pair. If all of the elements have failed, resistance will be infinite across all jumpered pairs.

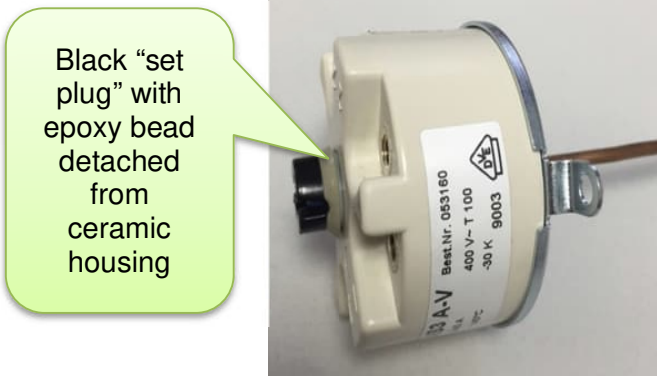
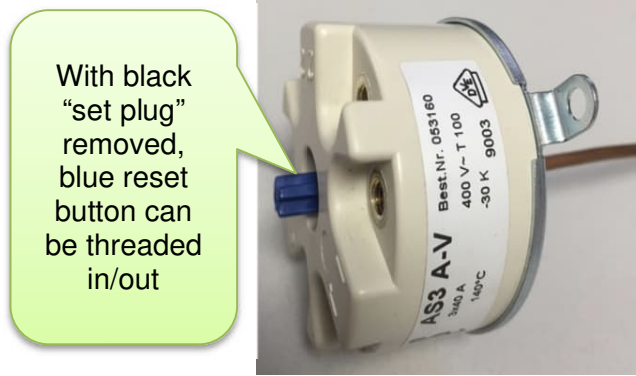
Inspect the epoxy securing the black “set plug” to the High Limit Switch’s ceramic housing, refer to the figures below and High Limit Switch Epoxy Failure Detail at the end of this document for details. If the epoxy has released from the housing, order kit W3T577679.

A bad epoxy seal on the CWP RO heater's High Limit Switch can present as a heater failure. The manufacturer is now using an improved epoxy process starting with heater lot number 1340332. The reset button is held in position by a "set plug" which is the component directly epoxied to the High Limit Switch's ceramic housing. If the epoxy fails, the "set plug" no longer secures the reset button, see figures on pg 3.

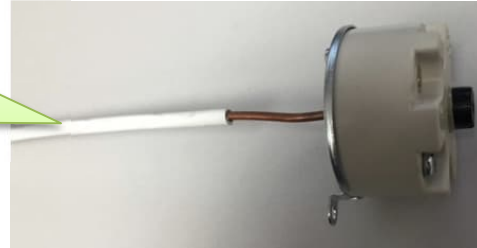
Confirm a white insulating sleeve is not present on the copper probe of the High Limit Switch. If one is present, remove and discard as it is not necessarily and may retain heat, refer to the figure below.

If white insulating sleeve is present, remove and discard

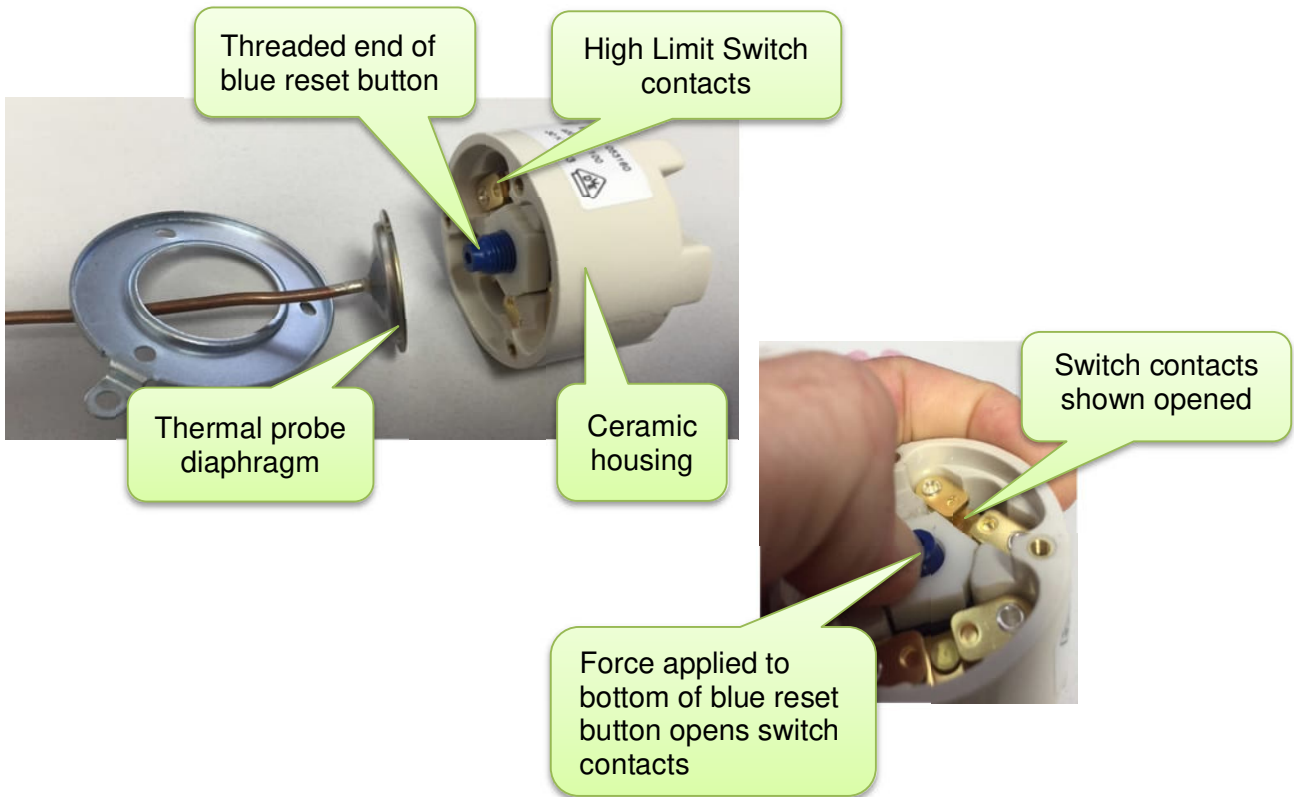
### High Limit Switch Epoxy Failure Detail

The blue reset button has a threaded connection at switch assembly. If the reset button is turned clockwise after an epoxy failure, it is forced against the diaphragm of the thermal probe in the switch assembly. This then pushes the switch contacts apart and opens the heater circuit as if the High Limit Switch has tripped.
